Post Remedial Action Report Lansdowne Radioactive
Residence Complex Dismantlement/Removal Project

June 1990

**Department of the Army
Baltimore District Corps of Engineers**

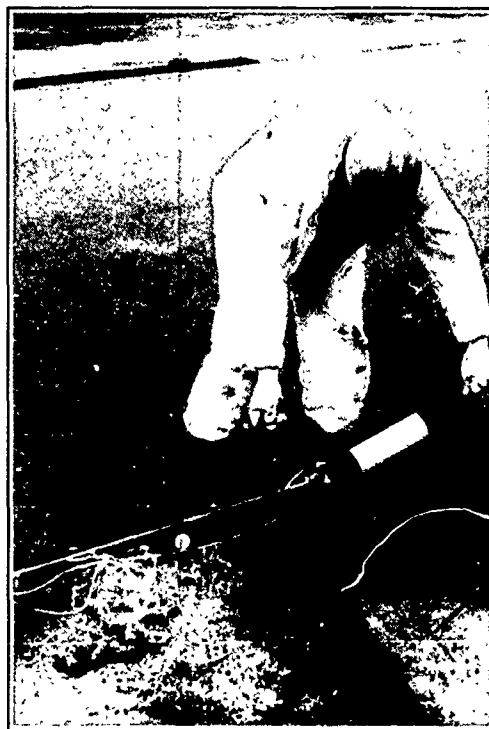
d. At the upstream manhole, the rope running through the sewer between manholes was tied to one end of the gamma probe for pulling it through the sewer in the downstream direction. Another length of rope was tied to the gamma probe for pulling it back through the sewer in the upstream direction.

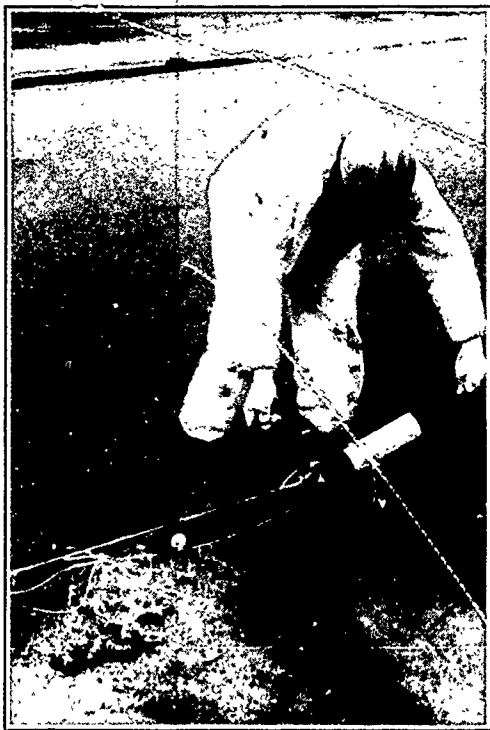
d. At the upstream manhole, the rope running through the sewer between manholes was tied to one end of the gamma probe for pulling it through the sewer in the downstream direction. Another length of rope was tied to the gamma probe for pulling it back through the sewer in the upstream direction.

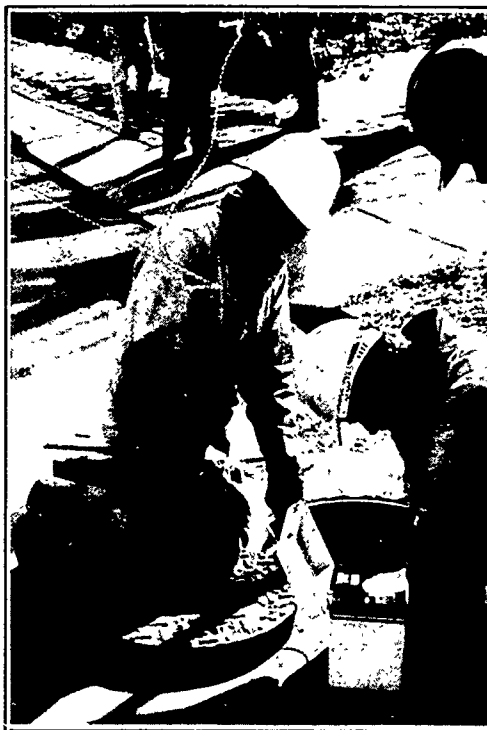
e. The 250-foot cable on the gamma probe being pulled through the sewer was connected to a multi-channel pulse height analyzer, which was calibrated to detect radioactivity in the energy range of radium.

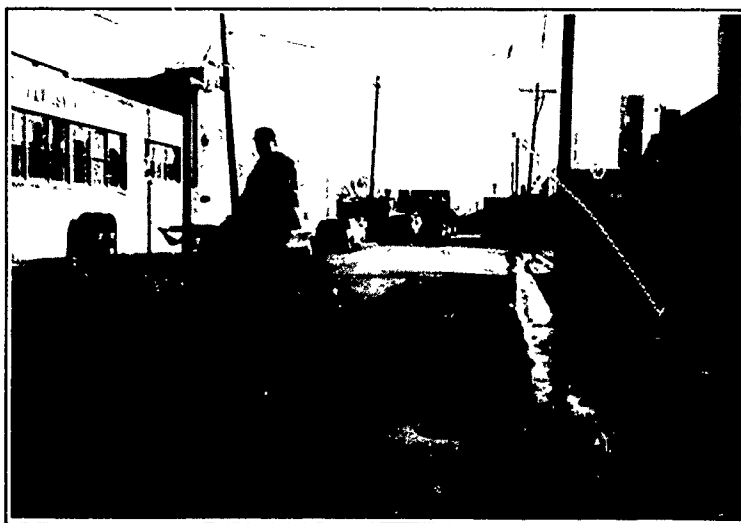
i. The investigation was not without problems, such as when the rope being used to pull the gamma probe through the sewer slipped out of the hands of the technician and plugged the sewer, causing it to overflow the manhole onto Union Avenue.

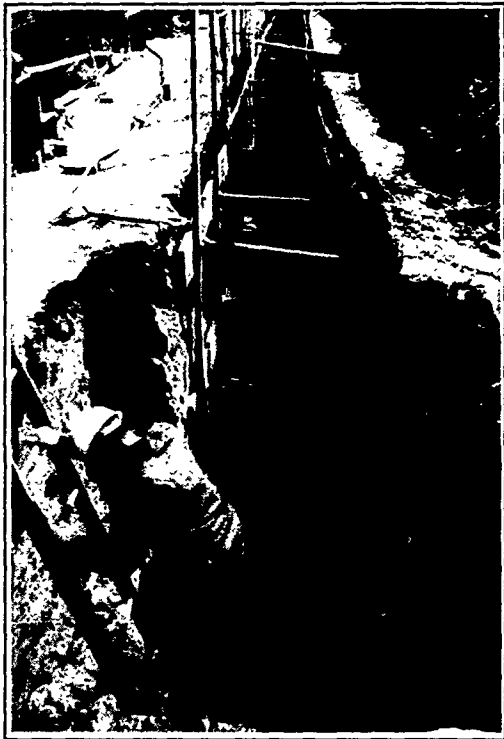
a. 4-foot wide trench was excavated and shored to expose the existing contaminated sewer line (right) and provide space for laying the replacement sewer line beside the existing line (b.). Photo taken facing downstream (east).

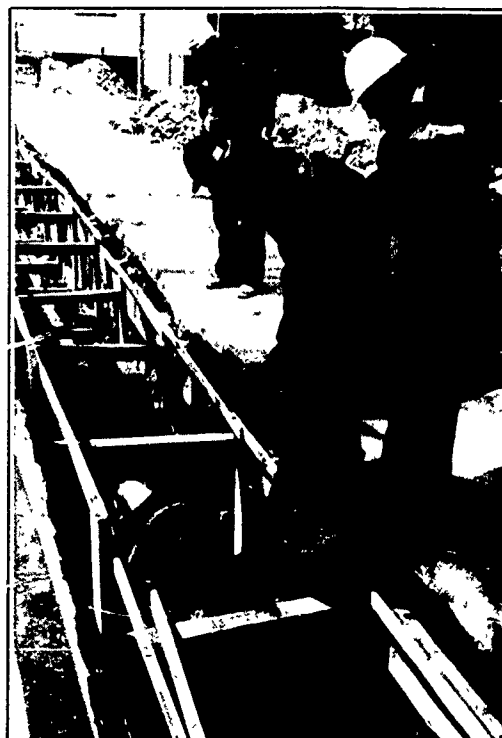
g. Filter fabric was quickly laid on the floor of the mucked out excavation.

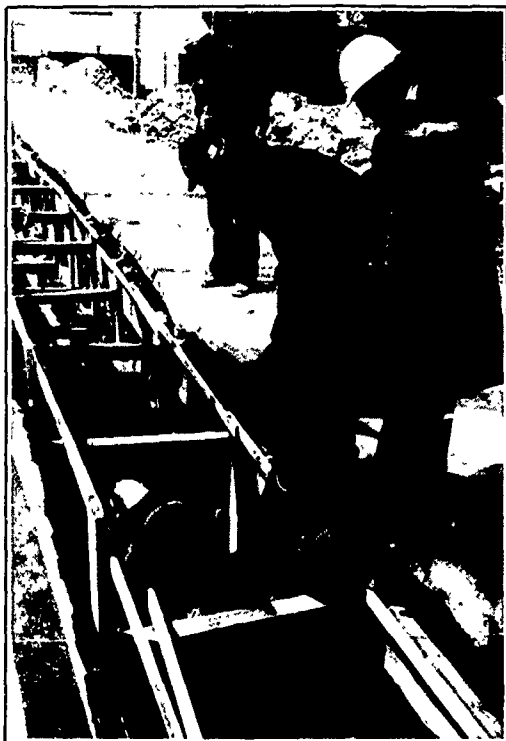
g. Filter fabric was quickly laid on the floor of the mucked out excavation.

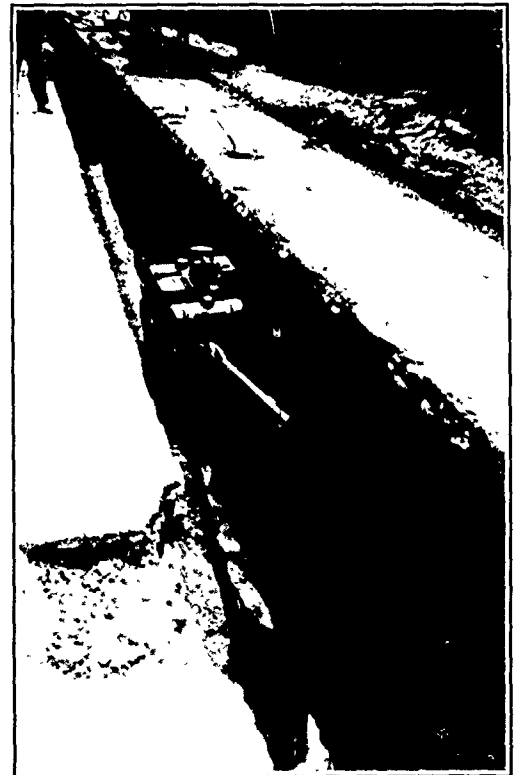
o. Backfill was compacted to 95%-98% maximum dry density.

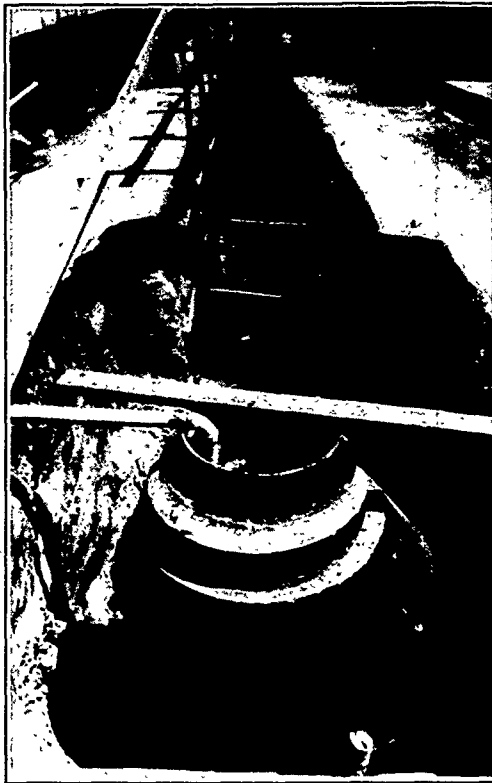
l. The ends of the filter cloth were spread out to overlap the French drain encasing the replacement sewer line. Construction of the new manhole was also completed.

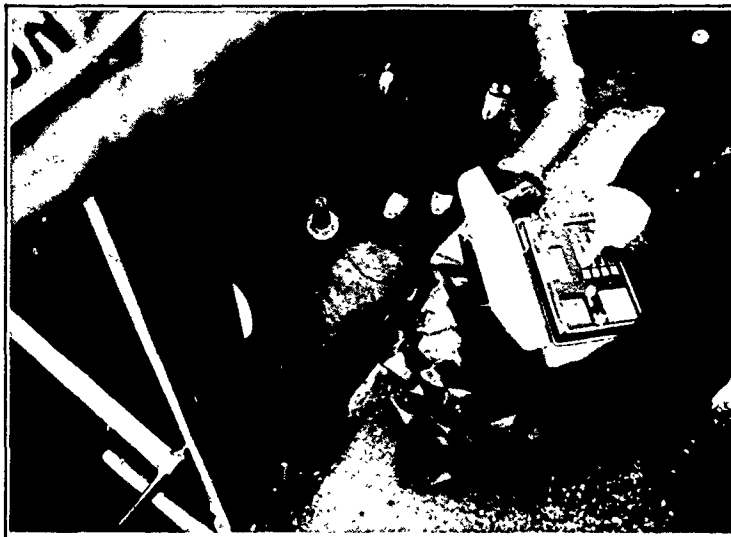
m. The old contaminated sewer line was taken up. Contamination which had leaked out of the line was located with a pulse-height analyzer and removed.

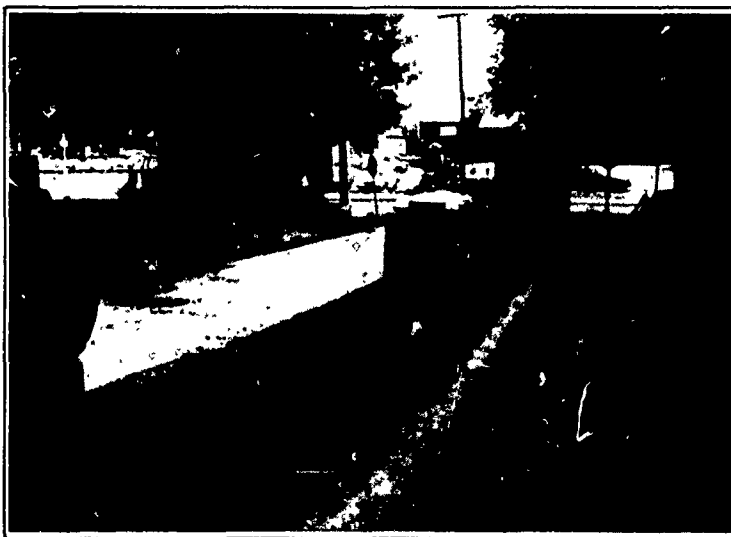
q. A 2-inch asphalt binder course brought the excavation back to original grade.

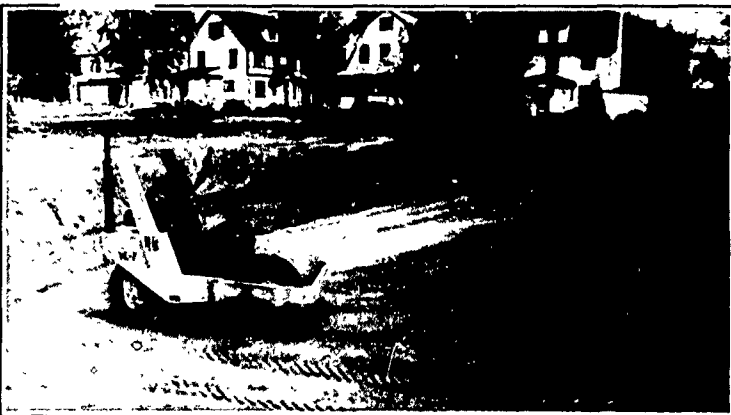
b. A Hyster VR-7 vibrating roller compacted the smoothed out excavation floor to 95% Proctor.

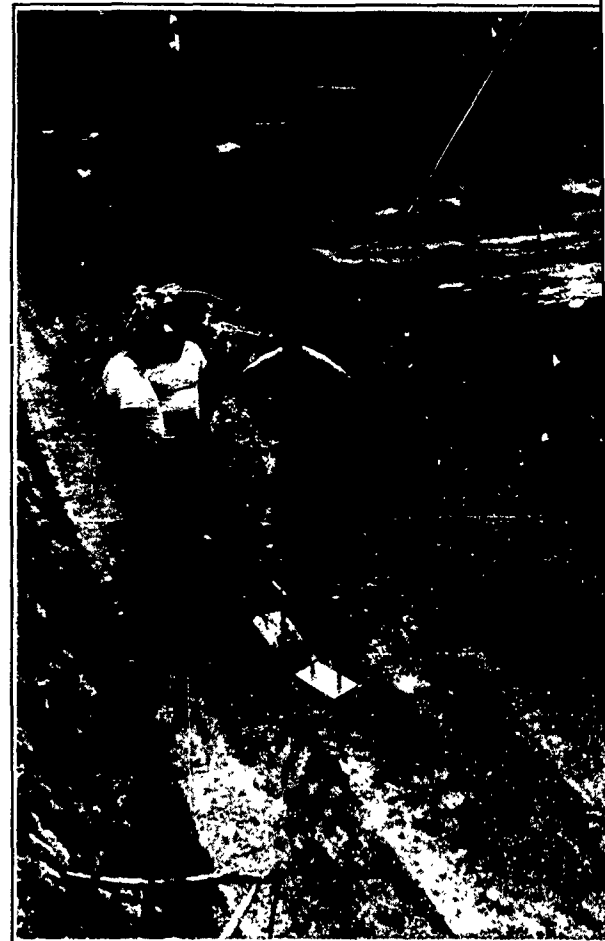
d. The backfill was compacted in 8-inch lifts to at least 95% Nuclear density tests were performed on each lift to ensure that compaction standards were being met.

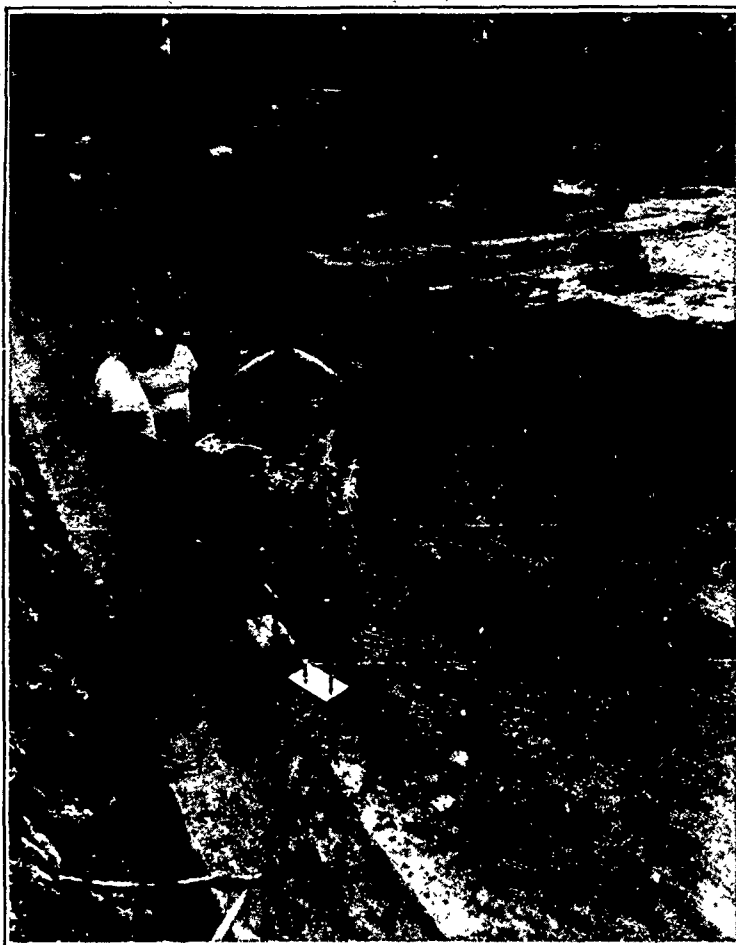
d. The backfill was compacted in 8-inch lifts to at least 95% Proctor. Nuclear density tests were performed on each lift to ensure that compaction standards were being met.

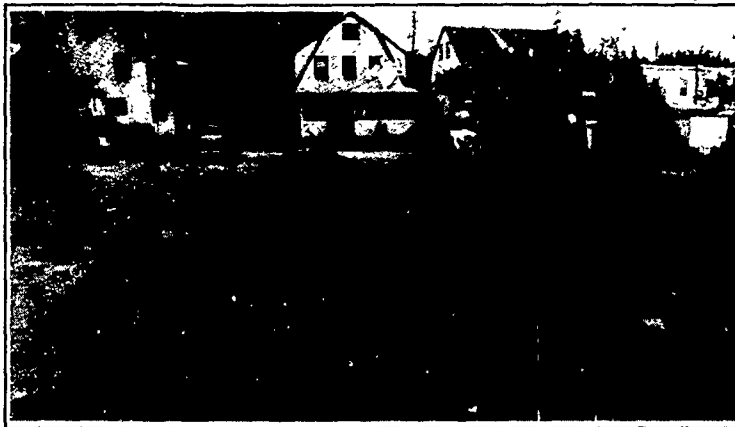
g. The topsoil was spread out in a 4-inch layer, seeded and mulched.

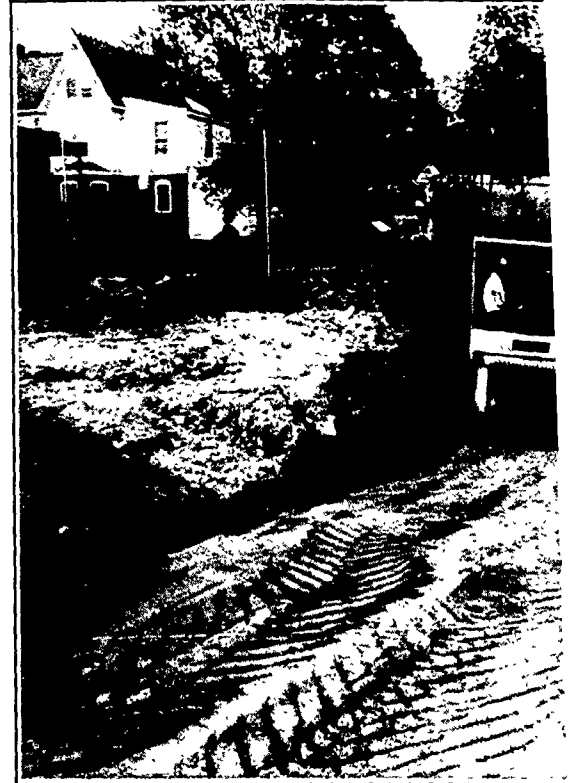
b. Removal of soft clay beneath the new location of the foundation. The excavation was backfilled with sand, compacted in layers. Photo taken facing west, May, 1989.

It was decided by the Government to put the 110 replacement-garage on a continuous strip-footing foundation. The base of the footing would be at the 3-foot depth, just below the frost depth for the Philadelphia region. It was assumed (correctly, it turned out) that after removing clay to the 3-foot depth, the foundation excavation would still be in clay. The Government therefore wanted to remove the clay to such depth, that, upon backfilling the excavation with compacted sandy soil to the elevation of the base of the footing, any clay, still underlying the footing at depth, would undergo only

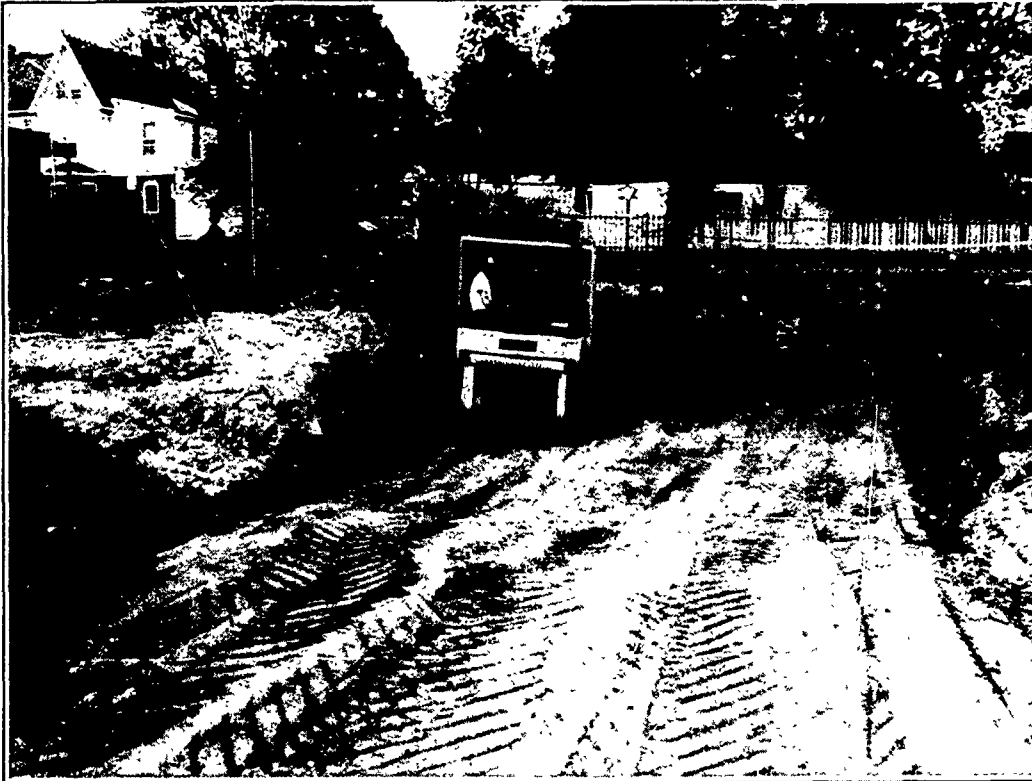
b. Removal of soft clay beneath the new location of the 110 garage created an excavation 9-feet deep. The excavation was backfilled with sand, compacted in 8-inch lifts to 98% maximum dry density. Photo taken facing west, May, 1989.

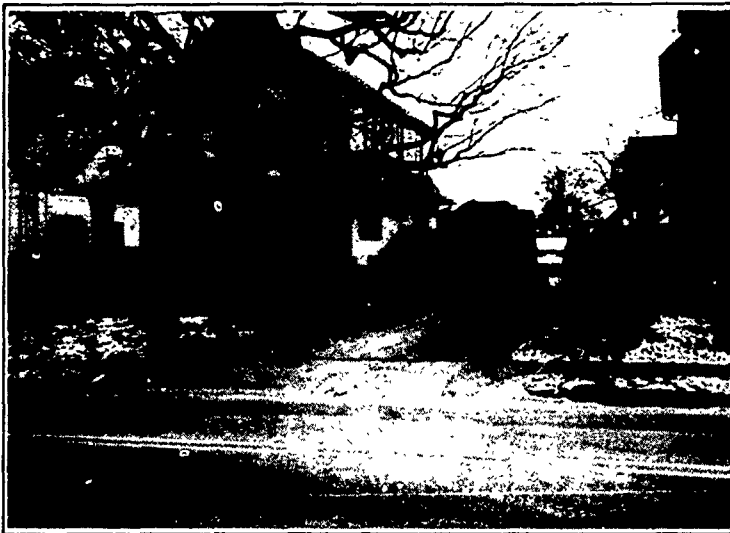
a. Forklift carrying a B-25 box loaded with contaminated soil out through the driveway at 110 E. Stewart. The driver made a left turn on E. Stewart and drove the box around the block to the OSF where it was processed for shipment to the disposal area. March, 1989.

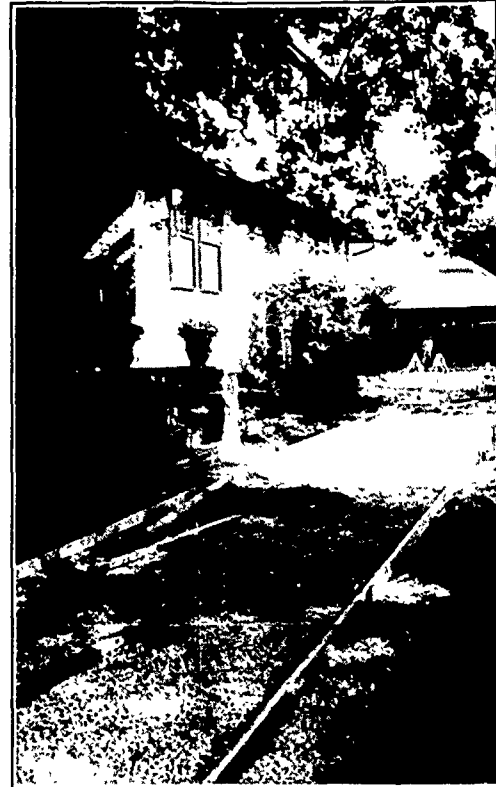
c. New driveway under construction at 112 E. Stewart. Four inches of concrete, reinforced with wire mesh, was poured. The driveway was constructed to replicate the original driveway, which was damaged by the forklift. June, 1989.

Replacement driveways and slabs were constructed of 3000 psi concrete, 4-inches thick, reinforced with 6"x6" welded wire fabric. The concrete was placed over a 4-inch basecourse of crushed 2-B limestone. Each of the driveway/parking slab units was approximately 100 feet in length. Expansion joints were constructed at 20-foot intervals.

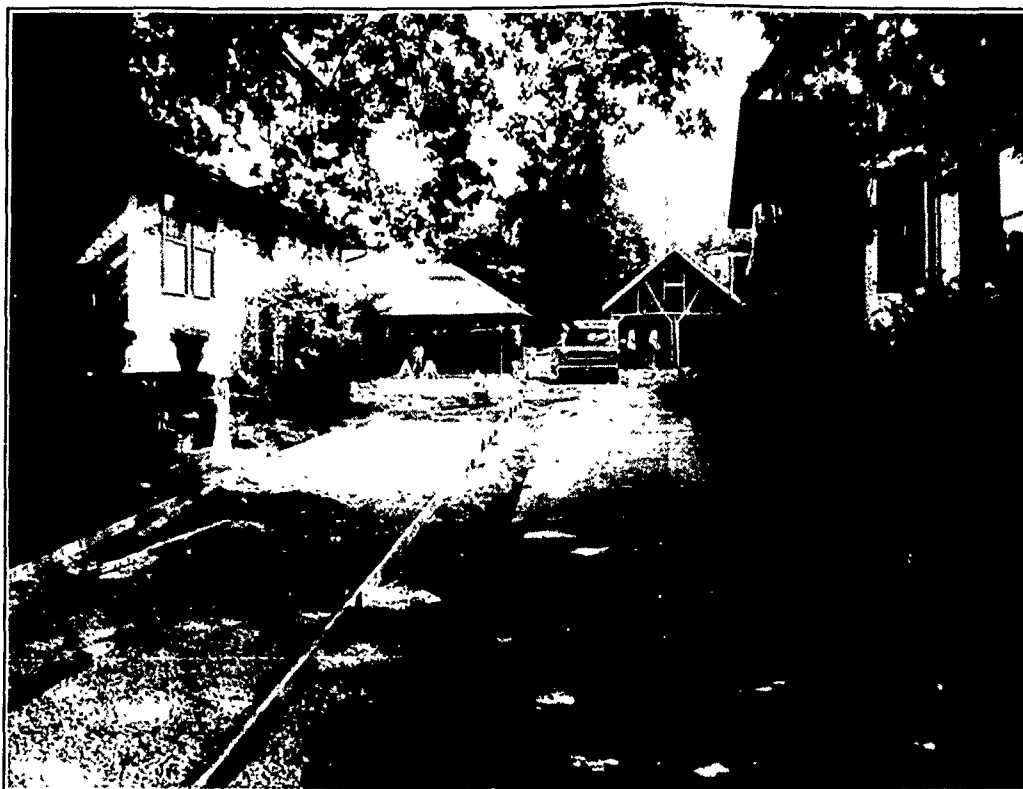
c. New driveway under construction at 112 E. Stewart. The basecourse seen in this photo is 4-inches thick. Four inches of concrete, reinforced with wire mesh, were poured over the basecourse. The replacement garages, which replicated those that were demolished, can be seen under construction in the background. June, 1989.

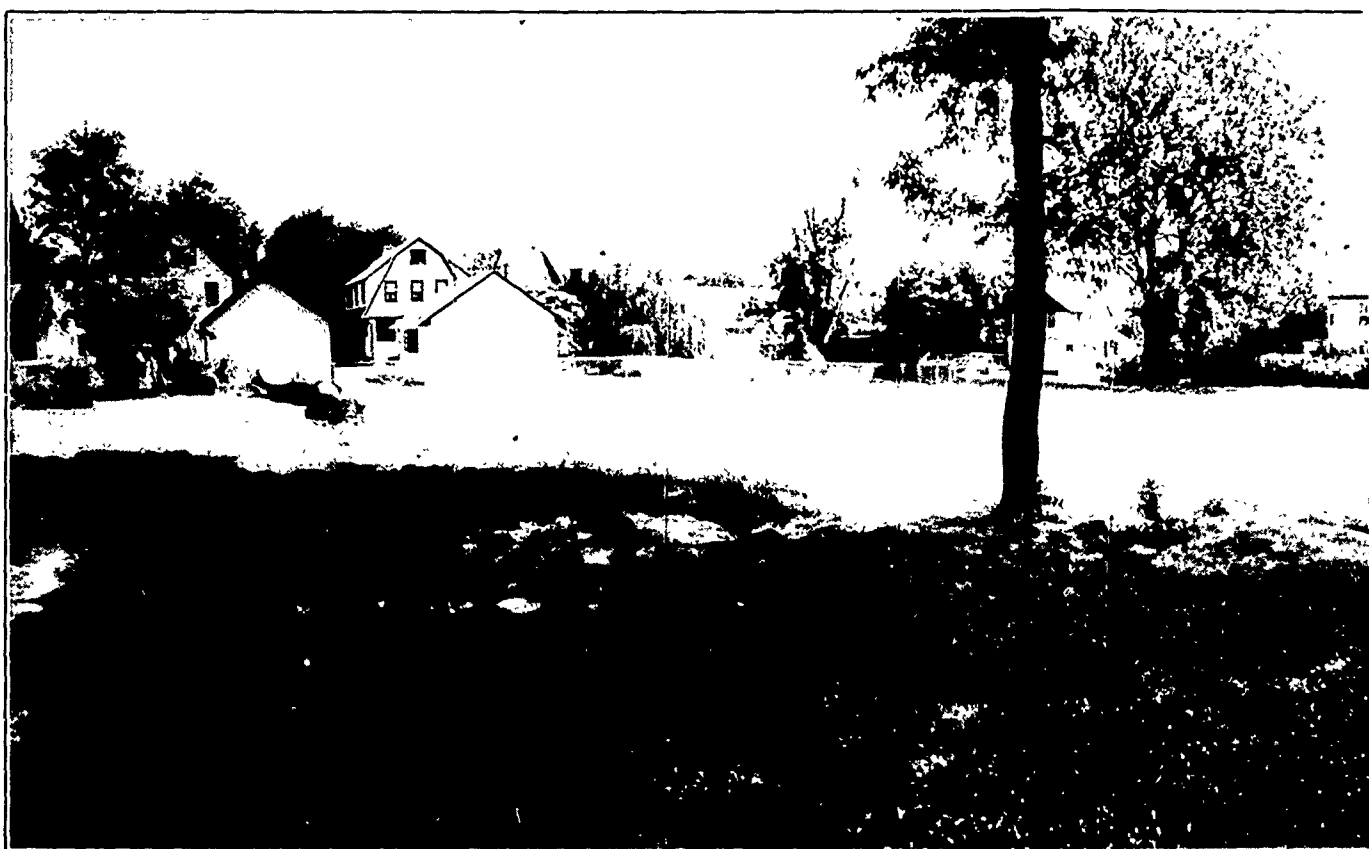
Fig. 9:4 - Jobsite In July, 1989, After Restoration

In accordance with contract specifications, the property was left as a grassed lot. The contour of the restored lot was modified so that approximately half the precipitation falling on it would drain in the direction toward the viewer in the photograph, and the other half would drain in the opposite direction. Compare Fig. 9:4 with Figs. 6:1 and 6:2, which were taken from the same perspective in August and December, 1988.

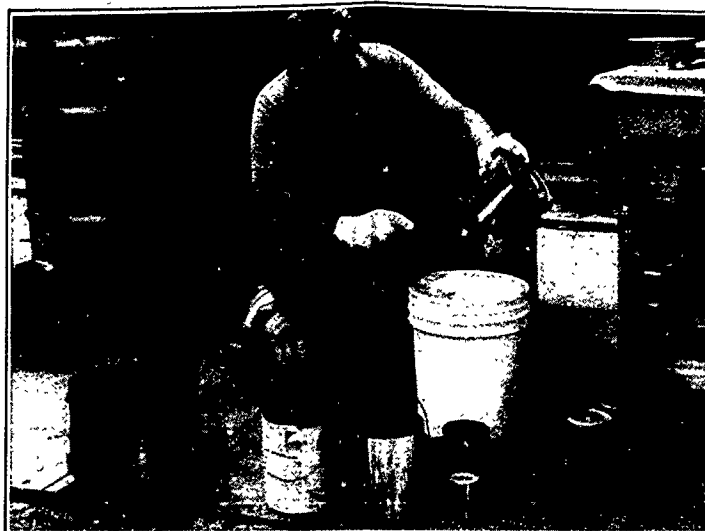
b. Preparing hazardous waste for shipment. The 105 basement contained numerous containers of paint and household chemicals which were held to be RCRA hazardous waste because the residence once contained a commercial enterprise. The containers and the contents posed a special disposal problem. Since the outside of the containers had unremovable radioactive contamination, they could not be disposed of at a site for toxic chemical waste, and the chemical contents of the containers prevented them from being disposed of at a rad-waste disposal facility. To solve the problem, the containers were emptied and the non-radioactive contents mixed in 5-gallon buckets which could be disposed of as hazardous waste. The empty radioactive containers were then disposed of as rad-waste.
